**PrimeSpec Consulting, LLC**

# **Inspection Report**

**Property Address:  
123 East Easy Street  
Gilbert AZ 85234**

| <b>Date:</b> 12/19/2010 | <b>Time:</b> | <b>Report ID:</b> |

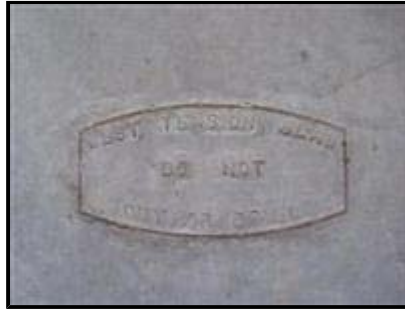
1.0 (1) Post tension slab installed. Do not drill or cut/core.

(2) Post tension slab installed. Do not drill or cut/core.

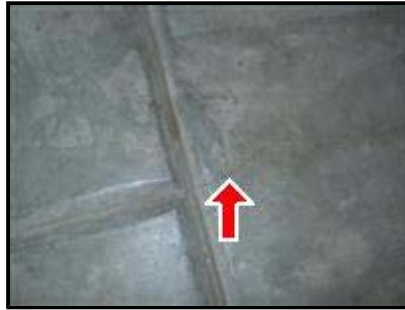
1.2 Cracks observed in concrete slab. These typical cracks are of no concern.

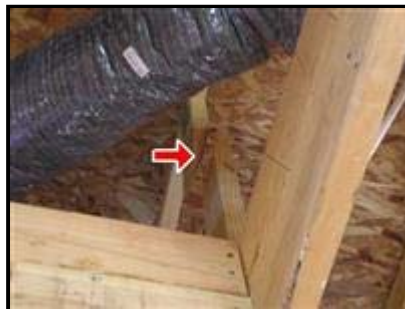
1.6 (1) The truss framing is broken (above Laundry Room). Truss repairs should be approved by an engineer before performing the work involved and I recommend a qualified contractor perform the work.

(1) The truss framing is broken (above Laundry Room). Truss repairs should be approved by an engineer before performing the work involved and I recommend a qualified contractor perform the work.

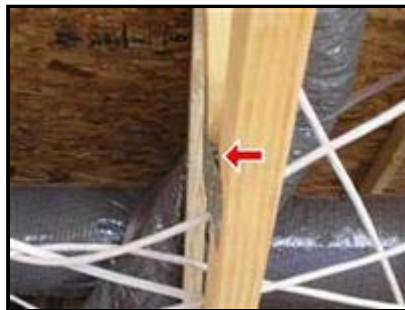
(2) The truss framing is loose at damaged nail plate (above Master bedroom). Some repairs or reinforcement may be required. For this reason, I recommend you contact an engineer or qualified person for a second opinion and repair if required.

(2) The truss framing is loose at damaged nail plate (above Master bedroom). Some repairs or reinforcement may be required. For this reason, I recommend you contact an engineer or qualified person for a second opinion and repair if required.

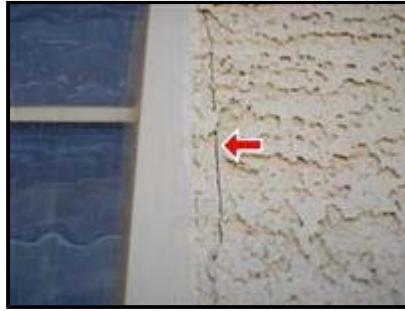
**2.0** Cracks observed in stucco are typical. This is a cosmetic issue for your information. No repairs are required at this time.

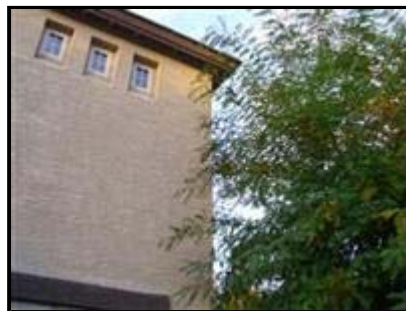
**3.0** Recommend trimming tree away from the exterior of the structure to prevent possible damage to walls.

Recommend trimming tree away from the exterior of the structure to prevent possible damage to walls.

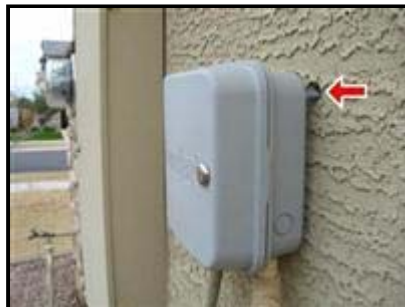
**4.0** Sprinkler timer is loose to wall. Recommend securing to prevent possible damage.

Sprinkler timer is loose to wall. Recommend securing to prevent possible damage.

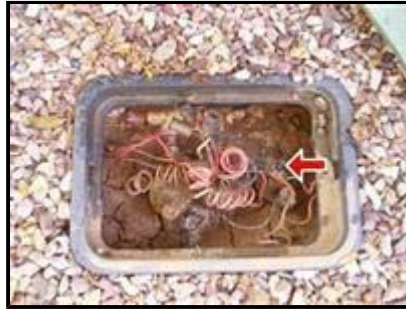
**4.1** Leakage noted at the lawn watering system valve in rear yard on east side of home. I recommend repair as needed.

Leakage noted at the lawn watering system valve in rear yard on east side of home. I recommend repair as needed.

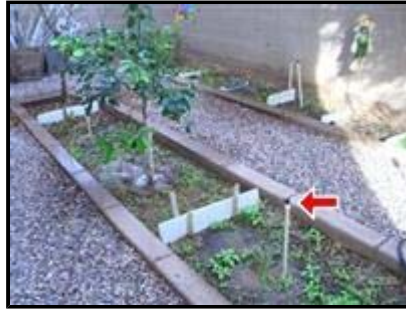
**4.4** Inoperable sprinkler head at the garden watering system in rear yard on east side of home. I recommend repair as needed.

Inoperable sprinkler head at the garden watering system in rear yard on east side of home. I recommend repair as needed.

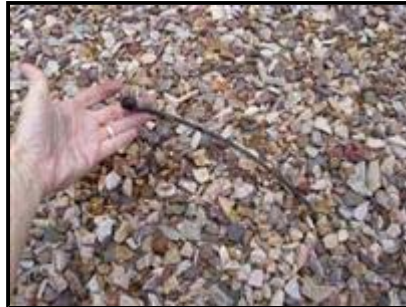
**4.5** Drip head observed water area where plant has been removed (east side of house in front yard). Recommend capping line or replacing plant.

Drip head observed water area were plant has been removed (east side of house in front yard). Recommend capping line or replacing plant.

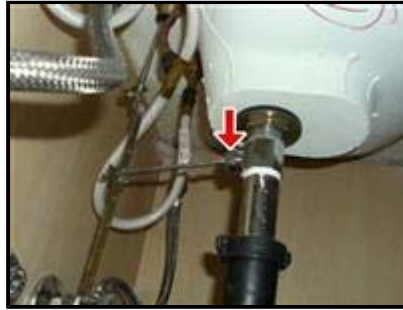
6.4 (1) The left sink drain is leaking from the stopper connection at the master bath. Repairs are needed to prevent possible damaged in cabinet. A qualified person should repair as necessary.

(1) The left sink drain is leaking from the stopper connection at the master bath. Repairs are needed to prevent possible damaged in cabinet. A qualified person should repair as necessary.

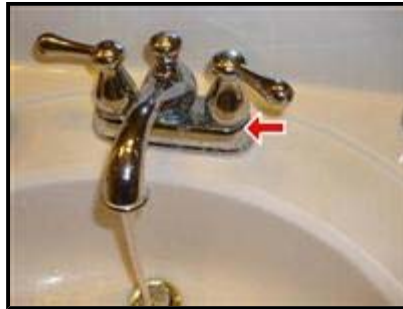
(2) The cold control handle has a minor leak onto counter at the 2nd floor hall bath. Repairs are needed. A qualified person should repair as necessary.

(2) The cold control handle has a minor leak onto counter at the 2nd floor hall bath. Repairs are needed. A qualified person should repair as necessary.

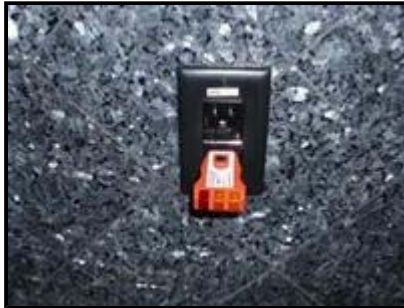
**+** 7.4 (1) GFCI (Ground Fault Circuit Interrupter) outlet at the Kitchen is defective, won't trip when tested. This is a safety issue that needs to be corrected. A qualified licensed electrical contractor should correct as needed.

(1) GFCI (Ground Fault Circuit Interrupter) outlet at the Kitchen is defective, won't trip when tested. This is a safety issue that needs to be corrected. A qualified licensed electrical contractor should correct as needed.

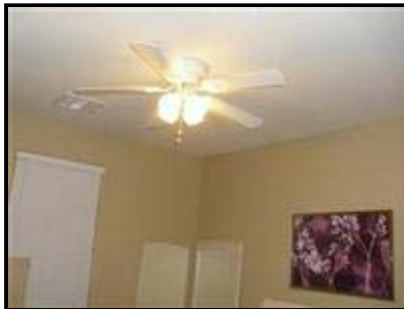
(2) The ceiling fan "wobbles" in the bedroom (at south/west 2nd floor bedroom). Some fans that wobble cannot be corrected without replacement. I recommend repair as needed.

(2) The ceiling fan "wobbles" in the bedroom (at south/west 2nd floor bedroom). Some fans that wobble cannot be corrected without replacement. I recommend repair as needed.

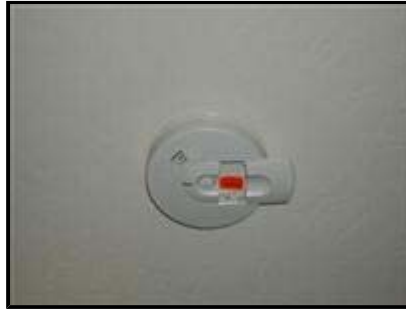
**+** (2) The smoke detector is missing its battery at the top of stairs. Without a working smoke detector in your home you have no first alert to a possible fire. I recommend replacing battery and testing for proper operation. Replace if required.

(2) The smoke detector is missing its battery at the top of stairs. Without a working smoke detector in your home you have no first alert to a possible fire. I recommend replacing battery and testing for proper operation. Replace if required.

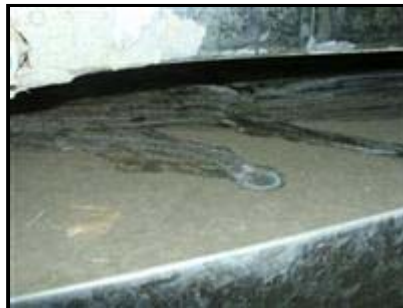
**9.0** Stains noted at drip pan below 1st floor air handler indicating past leaking. Recommend reviewing history of any past repairs with seller. If no repairs are documented than further evaluation and repair may be required by licensed HVAC contractor.

Stains noted at drip pan below 1st floor air handler indicating past leaking. Recommend reviewing history of any past repairs with seller. If no repairs are documented than further evaluation and repair may be required by licensed HVAC contractor.

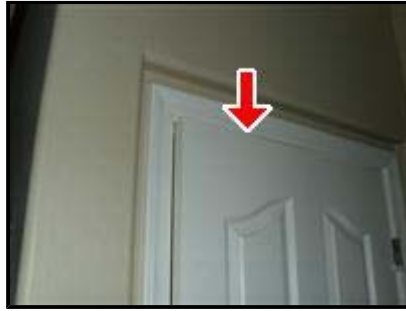
**11.4** The closet door below stairs rubs at top of door when closing. I recommend repair as needed for proper operation.

The closet door below stairs rubs at top of door when closing. I recommend repair as needed for proper operation.

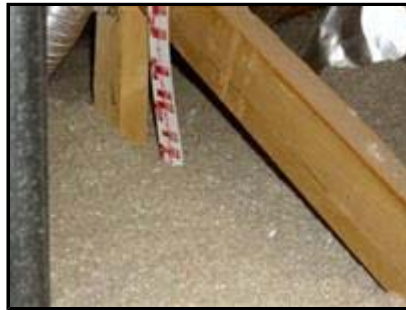
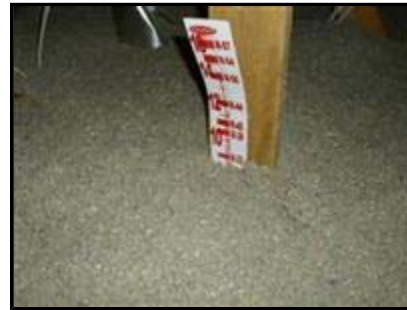
**12.0** Cellulose insulation is about eight inches thick or 30 R-Value.

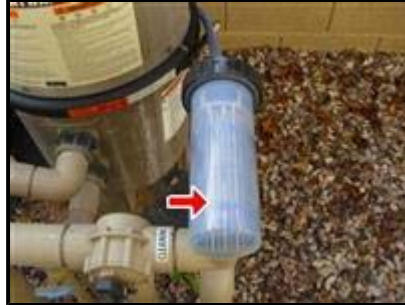
**14.9** Calcium build-up observed at salt cell. Excessive calcium can damage unit. Recommend cleaning.

Calcium build-up observed at salt cell. Excessive calcium can damage unit. Recommend cleaning.

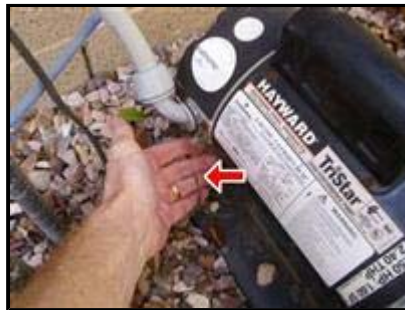
**14.11** External bonding (grounding) of pool pump motor is loose, this is a safety issue. Recommend reconnecting for proper bonding.

External bonding (grounding) of pool pump motor is loose, this is a safety issue. Recommend reconnecting for proper bonding.

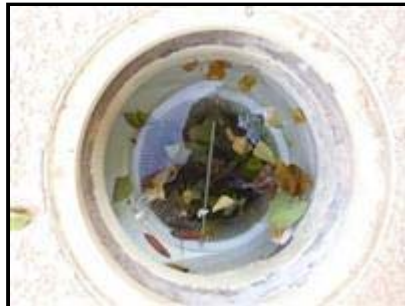
**14.15** Skimmer basket is full of debris. Recommend cleaning for proper water circulation.

Skimmer basket is full of debris. Recommend cleaning for proper water circulation.

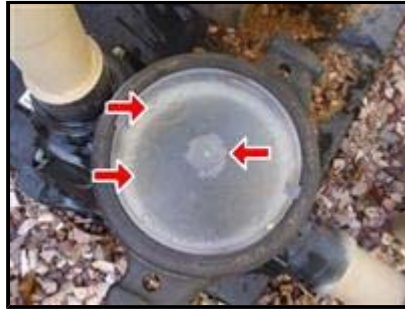
**14.16** A small amount of air bubbles were seen passing through the hair and lint filter on the pump. This is an indication of a minor leak somewhere along the suction side of the pumping system, which is likely occurring relatively close to the pump, at a valve, poor chlorinator fitting or at the O-ring under the hair and lint basket cover, but could also originate underground at a small pipe break. Problem is not serious at this time, but passage of air bubbles through the system should be monitored, and if their frequency increases, call in a pool or pump repair company to determine the source of leakage.

A small amount of air bubbles were seen passing through the hair and lint filter on the pump. This is an indication of a minor leak somewhere along the suction side of the pumping system, which is likely occurring relatively close to the pump, at a valve, poor chlorinator fitting or at the O-ring under the hair and lint basket cover, but could also originate underground at a small pipe break. Problem is not serious at this time, but passage of air bubbles through the system should be monitored, and if their frequency increases, call in a pool or pump repair company to determine the source of leakage.
